City Park Golf Course Cultural Landscape Assessment

Denver, Colorado
August 2017

Prepared for:
City and County of Denver
Department of Public Works
201 West Colfax Avenue
Denver, CO 80202

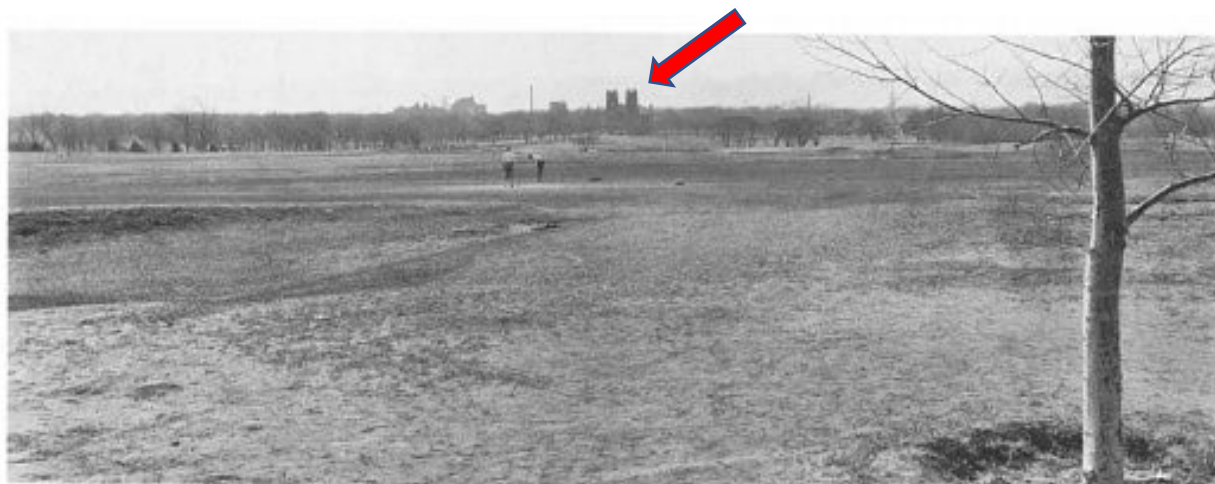
City Park Golf Course looking west in 1913. The spires of Saint Ignatius Loyola Church are visible on western edge of course.
Figure 1. City Park Golf Course in 1913

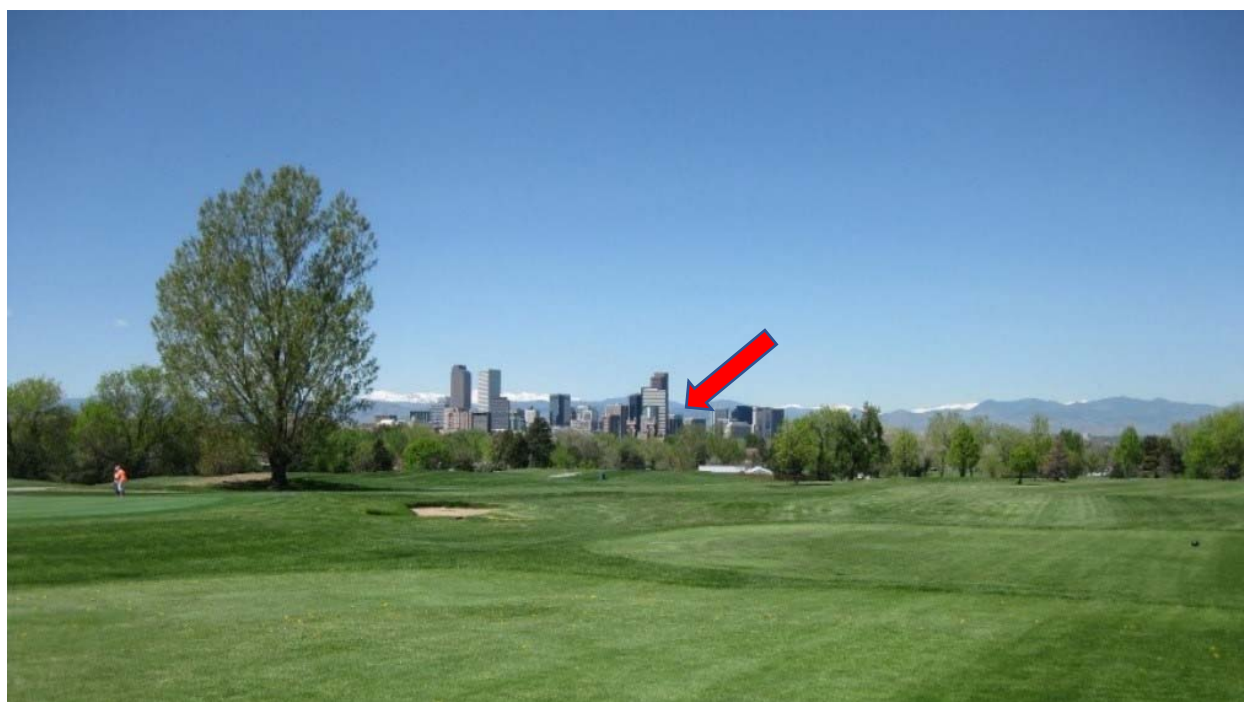
City Park Golf Course looking west in 2016. The spires of Saint Ignatius Loyola Church are located behind trees (red arrow).
Figure 2. City Park Golf Course in 2016

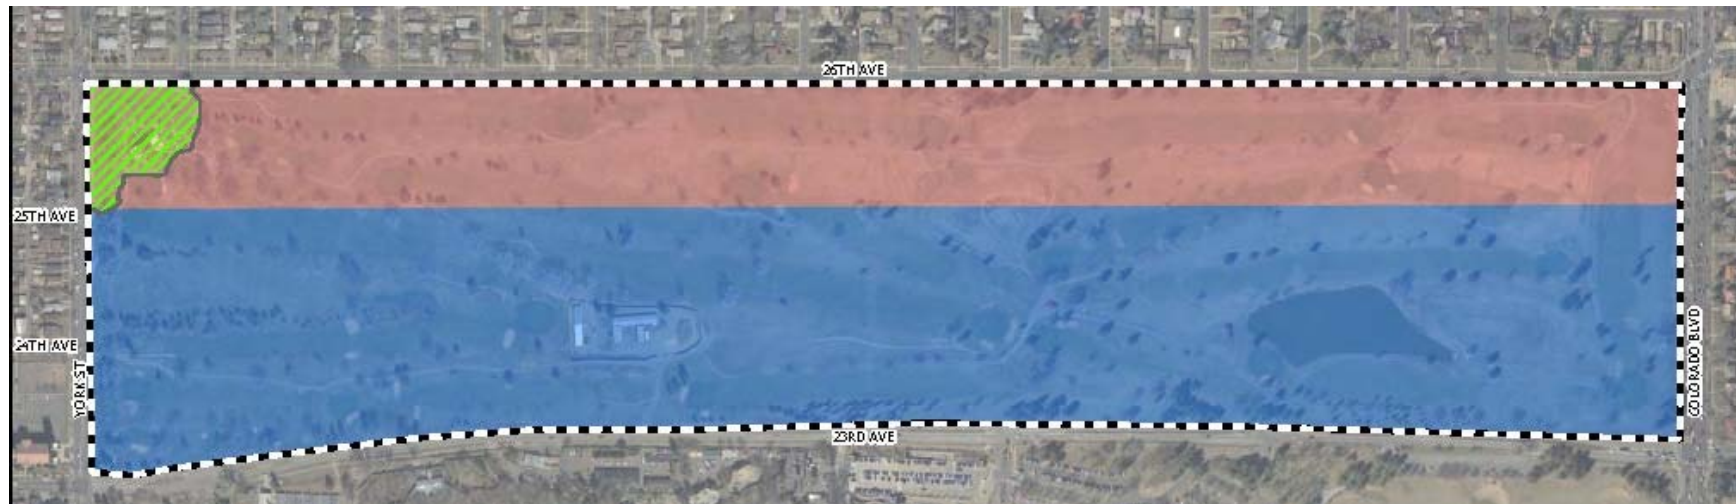
Figure 5. Overview of City Park Golf Course showing original and expansion areas.

Map shows area of original 1913 9-hole course (in blue) and area opened in 1914 (red). Green area shows location of historic and current clubhouses

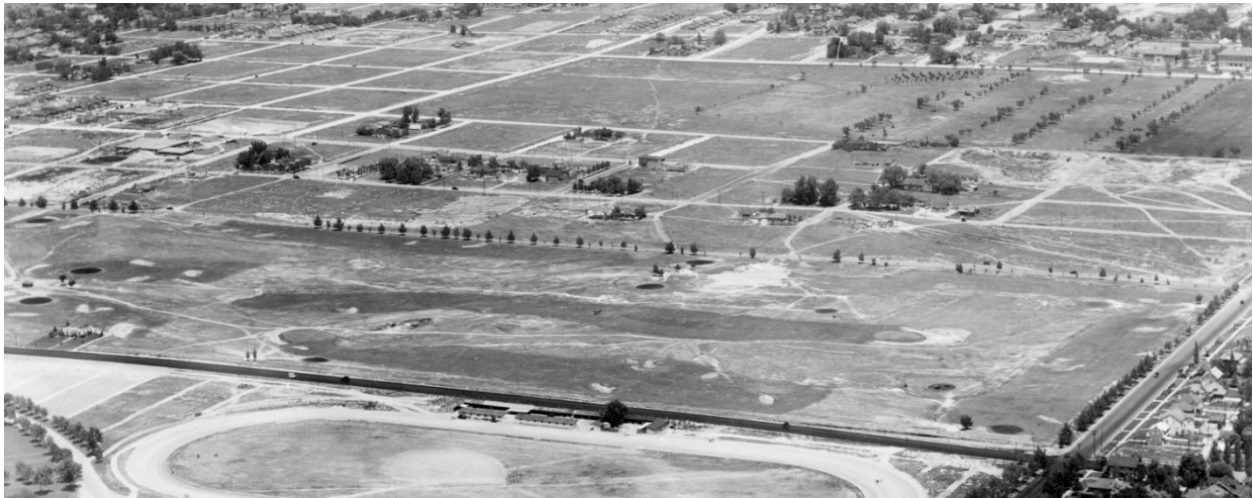
Note tree plantings along eastern and northern edges of course and 23rd Avenue along southern edge

An early aerial photograph of the course, taken around 1923 (see Figure 11), shows that trees had been planted along the course's perimeter, on the south curb line of 26th Avenue between Josephine Street and Steele Street; on the west side of Colorado Boulevard between 26th Avenue and 23rd Avenue; near the intersection of 23rd Avenue and York Street; and on the east side of York Street between 23rd Avenue and 26th Avenue, encompassing the clubhouse. Only a small number of trees were planted on the course itself, and several greens are still a sand/oil mix. In fact, the course maintained a link-style design with few trees until the 1960s.

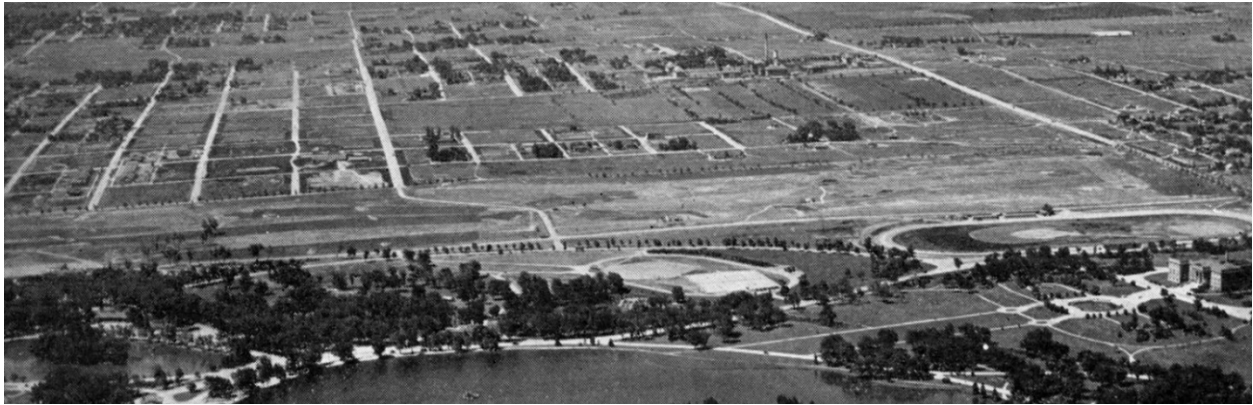
Figure 13. Aerial View of City Park Golf Course, circa 1935

Note road running north-south across course (at Steele). At this time, all greens appear to have been planted with grass.

The City Ditch, which crossed CPGC and serviced agricultural operations, extended north of the course. It appears that the ditch ran across the land that would become City Park and CPGC as early as the 1870s. According to records found in the Denver Parks and Recreation Department, in the 1890s, the flow of water was cut off to the area north of City Park due to health concerns. When City Park was developed, water from the ditch was used for irrigation, and by the mid-1890s, the portion of the ditch that ran across the park was filled in, and the water flowed through pipes that had been installed. The ditch ran across the golf course until the 1950s when, according to city records, it appears that the ditch was filled in as part of a 1955 City Bond Fund program that focused on water improvement projects. During the 1930s, a brick-lined sewer was installed that ran across City Park, the golf course, and then north under York Street. The scar from that installation is visible on Figure 13.

Sometime during this period, a maintenance yard was constructed. The aerial image taken in 1933 (see Figure 13) shows a yard and building in the same location as today's maintenance

facility. The yard was likely expanded in the 1950s since it is similar to a yard built at another city-owned course (Willis Case) in 1954.¹⁷

An early aerial photograph of the course, taken around 1933 (Figure 13), shows that some trees had been planted along the course’s perimeter. Trees were located along the south curb line of 26th Avenue between Josephine Street and Steele Street; on the west side of Colorado

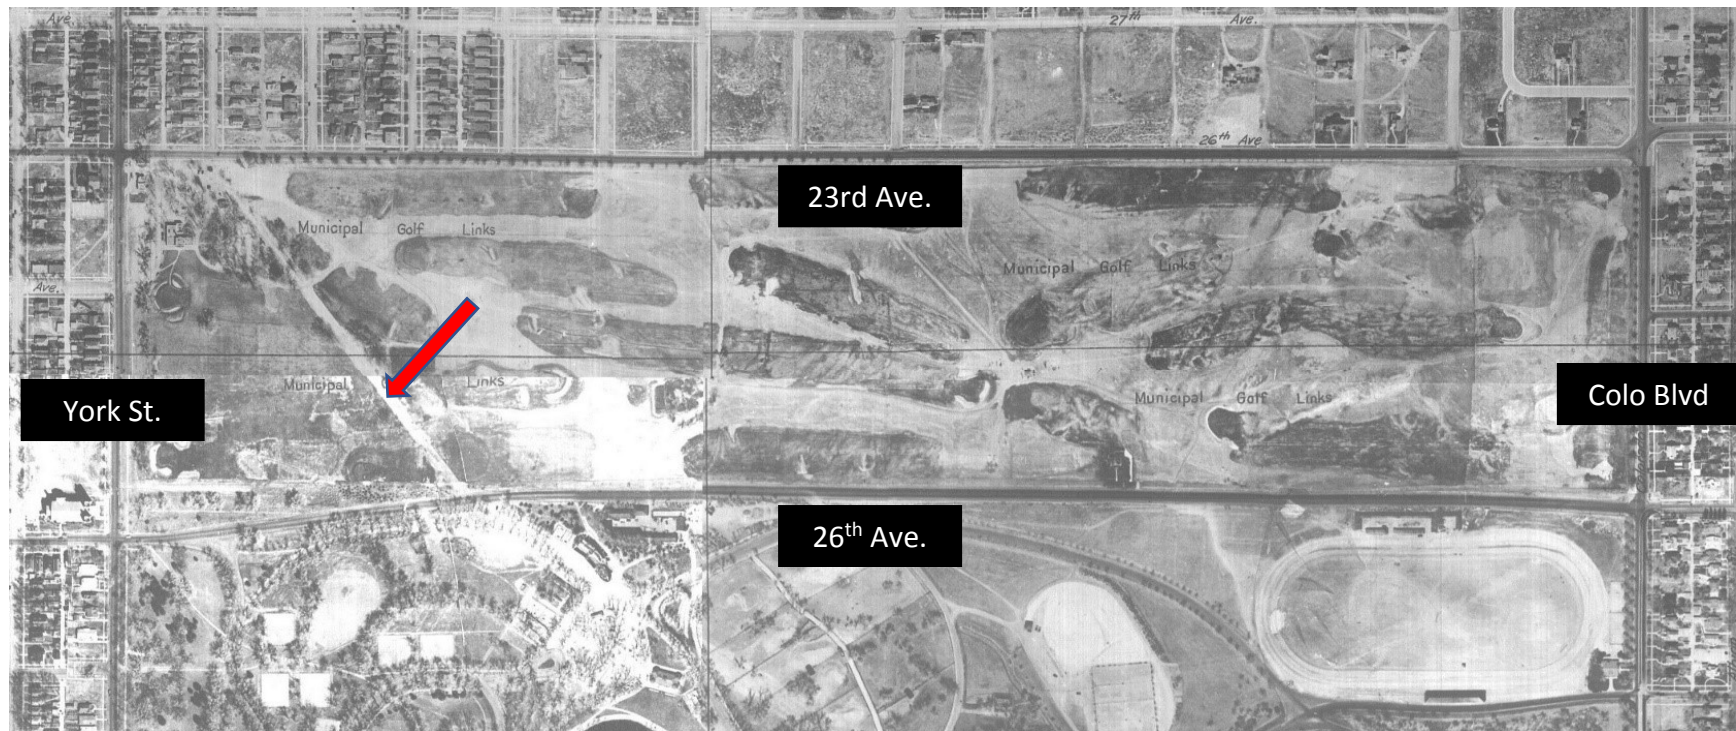
Note tree plantings along course boundaries, 23rd Avenue running along southern edge of course, and open areas between fairways Red arrow shows path of sewer line.

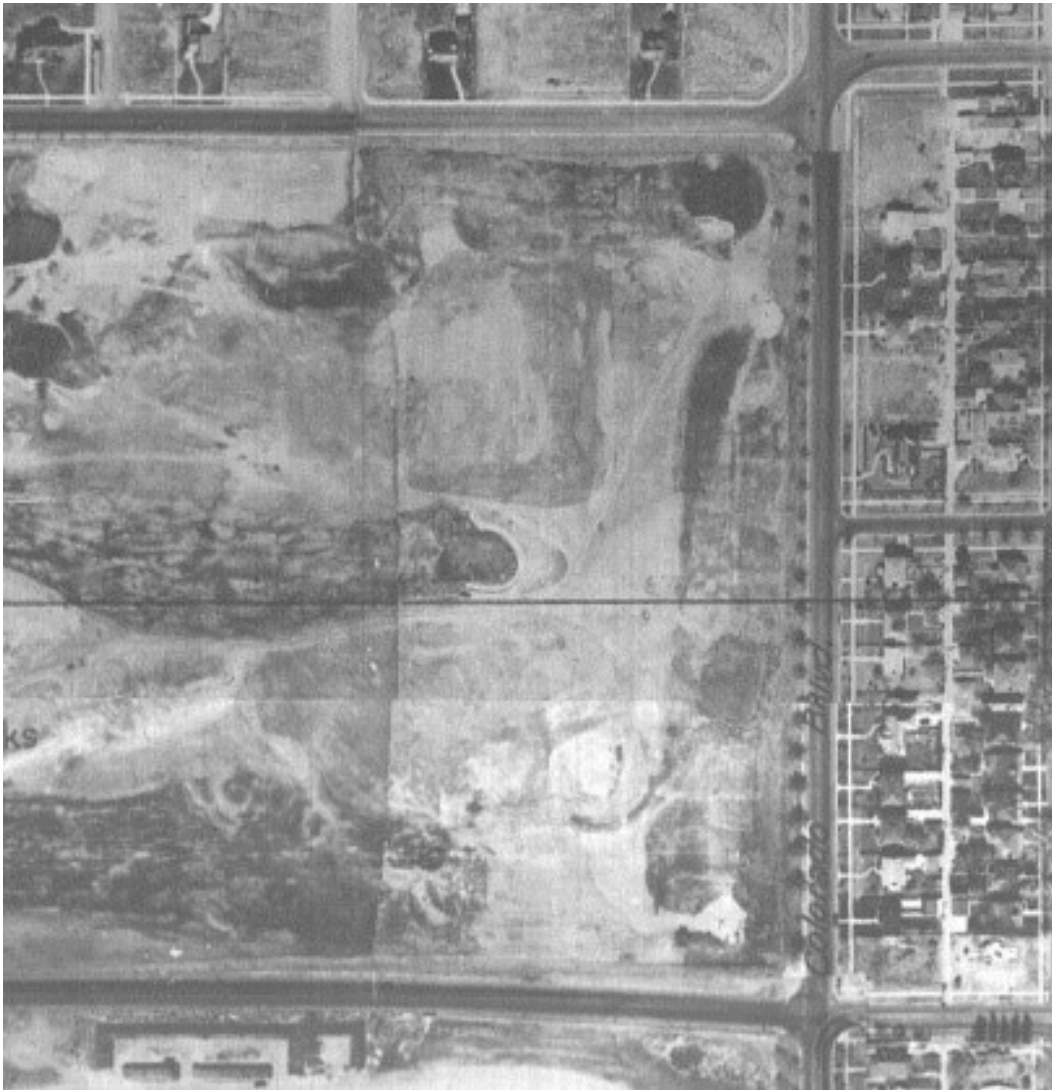
Note narrow width of Colorado Boulevard and row of trees along street and configuration of fairways.

Figure 16. Detailed View of the Eastern Side of the Course, circa 1935

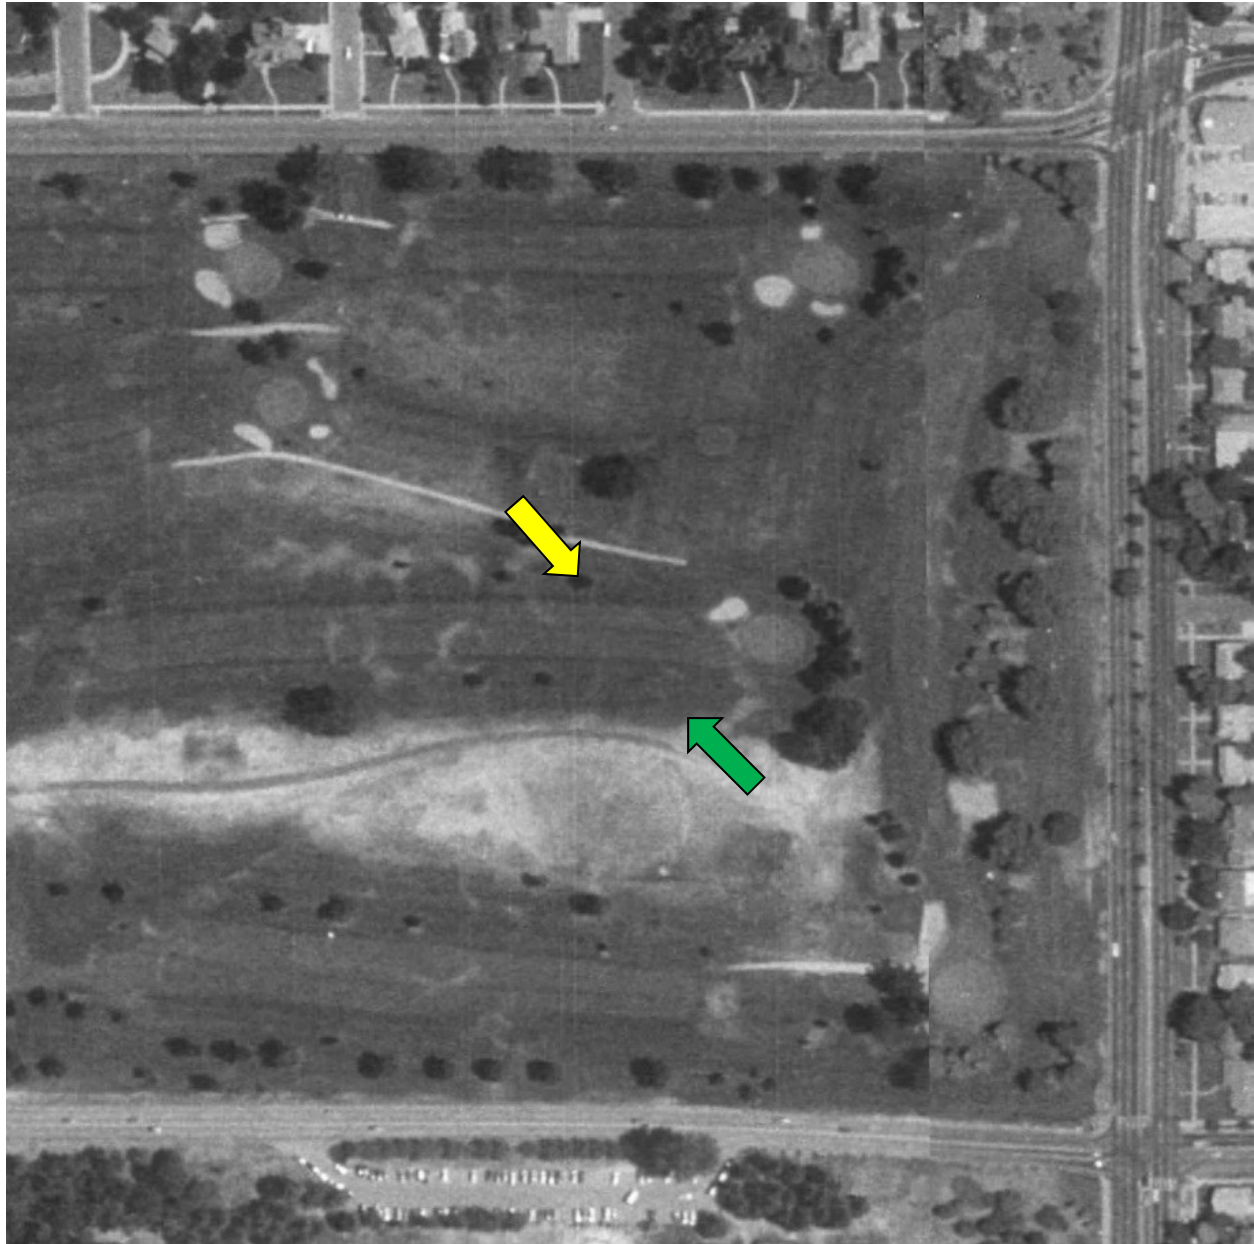
Note expanded width of Colorado Boulevard and modified configuration of fairways. Arrows indicate area affected.

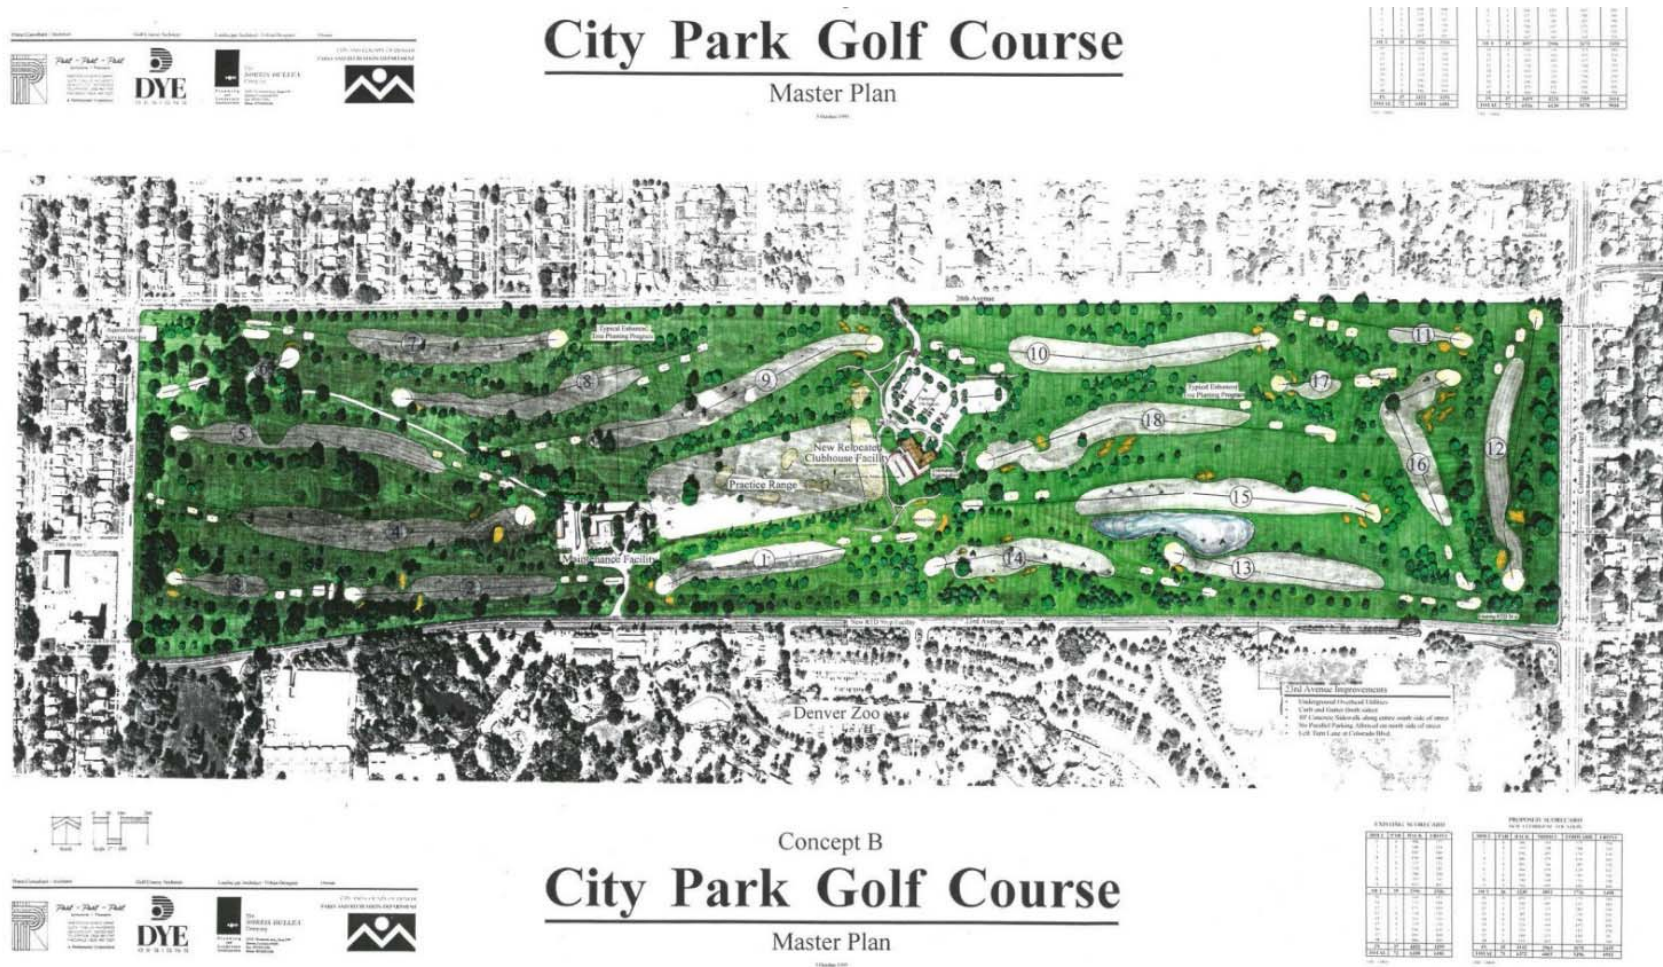
Figure 18. 1995 City Park Golf Course Master Plan

Source: City of Denver Public Works Department
Note location of clubhouse in middle of course.

In 1995, a re-design of CPGC was considered that shared certain concepts with both the mid-1940s proposed design and the current proposed plans. In all three re-design concepts, a new clubhouse has been proposed for the highpoint of the course to take advantage of the spectacular views.

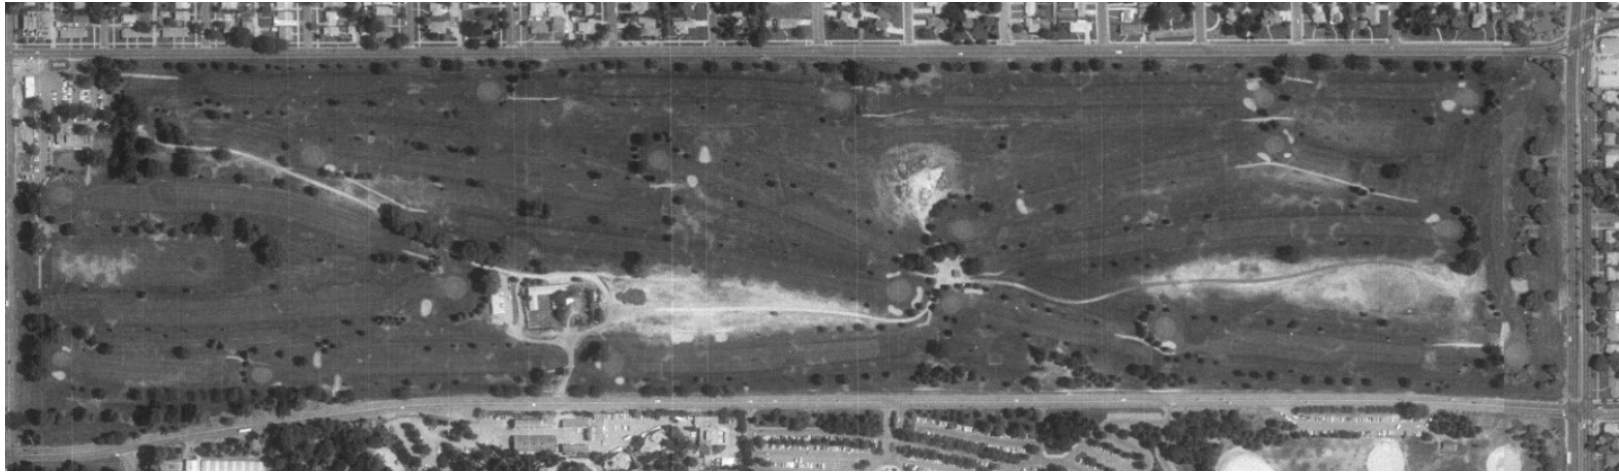
Figure 19. Aerial View of City Park Golf Course, circa 1995

Source: City of Denver Public Works Department
Note open dirt areas between grass-covered fairways.

As recently as 1995, an aerial photograph (see Figure 19) clearly reveals that many areas between the fairways were not irrigated and aesthetics were far below the current standard for modern golf courses. Efforts to bring the course up to current standards required the removal a total of a small number of trees due to the balancing of the earthwork from the construction of the irrigation pond. Trees were planted on the east end near Colorado Boulevard (hole 5), and in focused areas along 23rd Avenue and around the driving range. This is clearly noticeable in a sequence of aerial photographs from 1995 (Figure 19), 2008 (Figure 20), and 2014 (Figure 21).

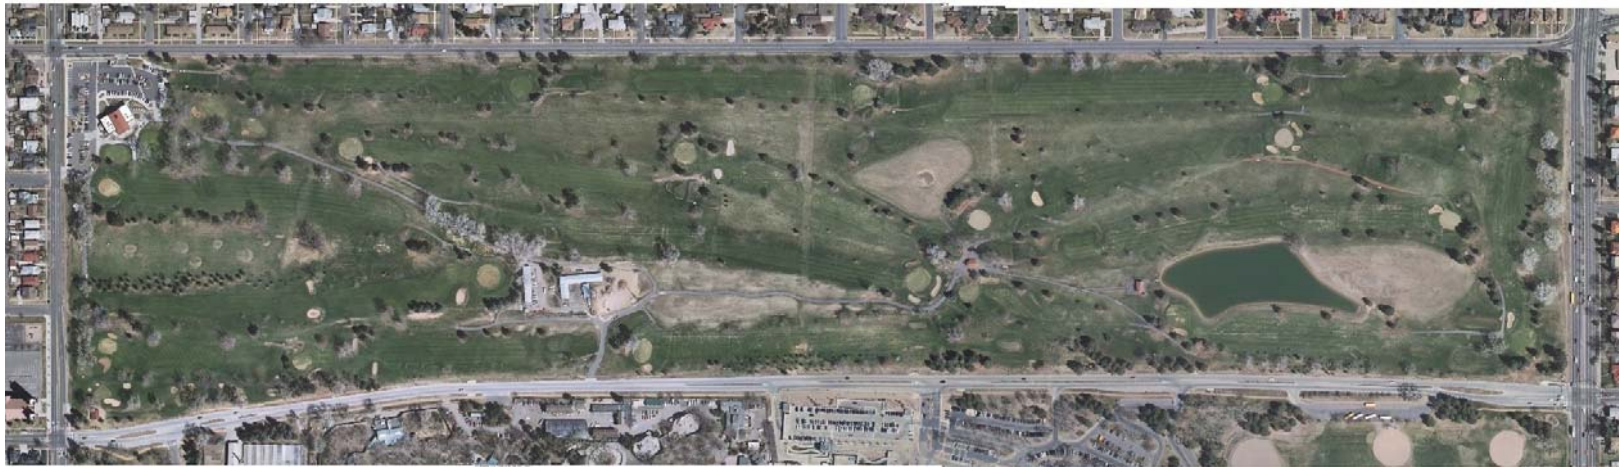
Figure 20. Aerial View of City Park Golf Course, circa 2008

Source: City of Denver Public Works Department
Note some of the areas not covered with grass are left as natural or no-mow areas and the addition of the pond and hills on the eastern side of the course.

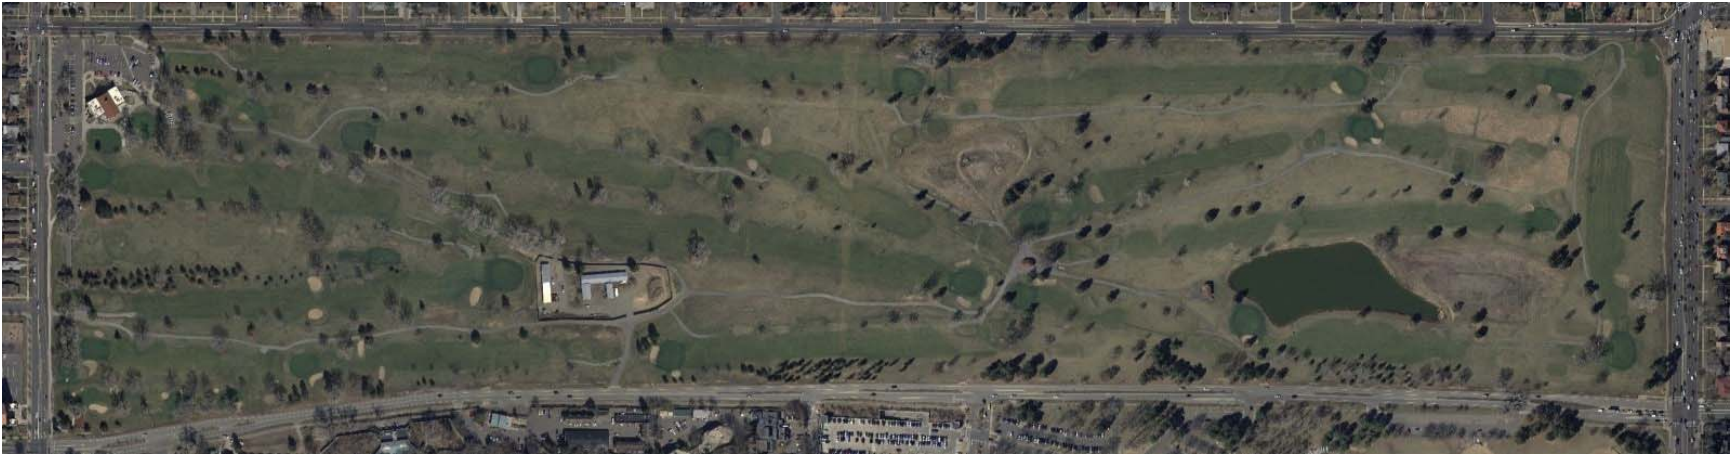
Note complete coverage of course with grass and more extensive vegetation.

In addition to grass, the installation of irrigation systems facilitated increased plantings of trees and other vegetation. As noted above, some trees were in place around the perimeter of the course as early as the 1930s. While some trees remained from the tree nursery that had existed at the site, others appear to have been planted as part of the course development. More extensive tree and shrub planting began in the 1950s, setting a gradual pattern that continues today. Director of Golf and Maintenance, Babe Lind, oversaw the tree plantings around the greens that could benefit from the regular irrigation those areas received. It appears that many of the trees planted by Lind were those identified in the 1986 NRHP nomination. A 1995 aerial photograph illustrates how much more of the course had been covered by vegetation (see Figure 19). Figure 26 shows how the entire course is now covered with grass.

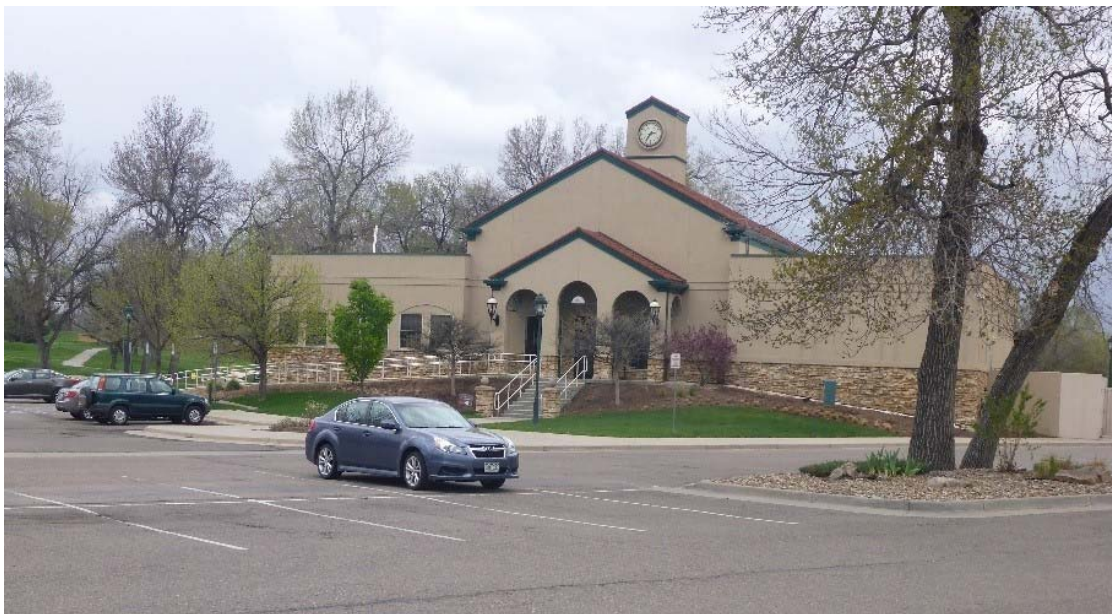
Figure 22. 2001 Clubhouse and Parking Lot Looking Southeast

As noted above, the buildings listed in the 1986 National Register nomination (the clubhouse, starter house, and snack bar/toilets) were all removed in 2001. The storage/maintenance yard fixtures remain in the location they occupied in 1986. Those buildings that have been removed no longer contribute to the historic integrity of the site, but their replacements (the 2001 clubhouse and snack shack bar; see Figure 22, Figure 23, and Figure 24) are located in approximately the same spot, and so maintain the spatial patterns that have been in place since the early 1920s.

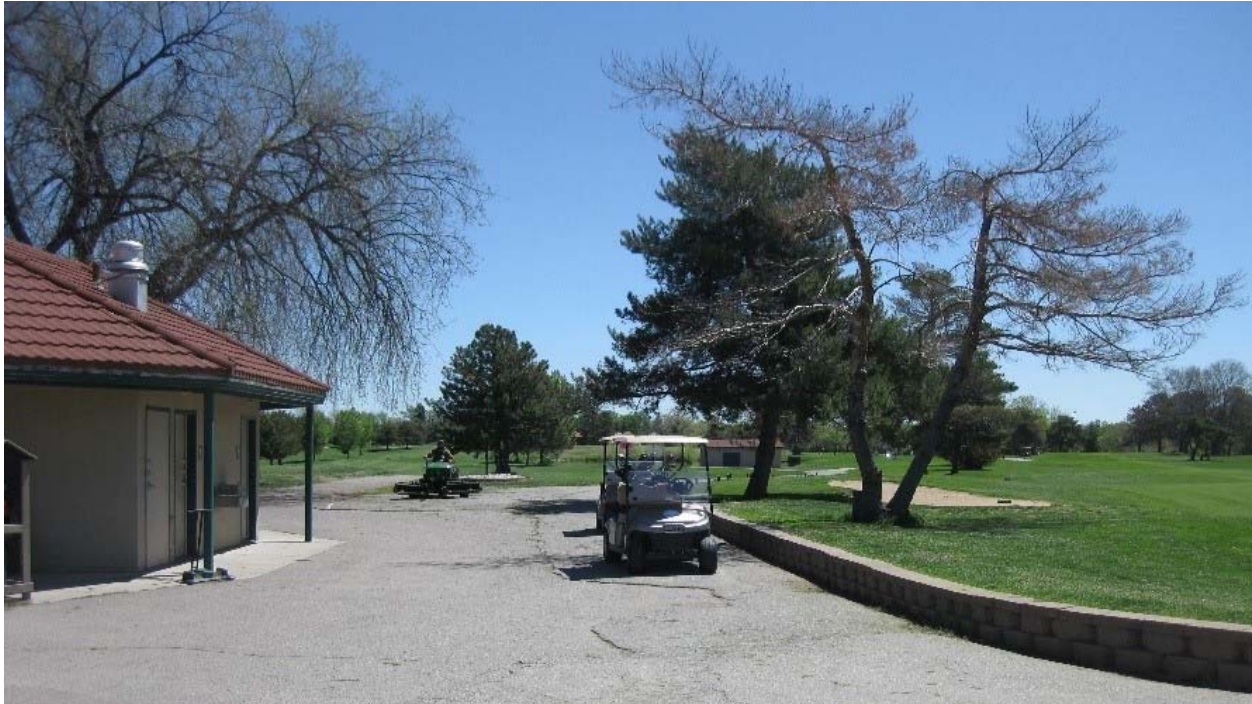
Figure 23. 2001 Snack Bar and Toilet Building, with Cart Parking Area

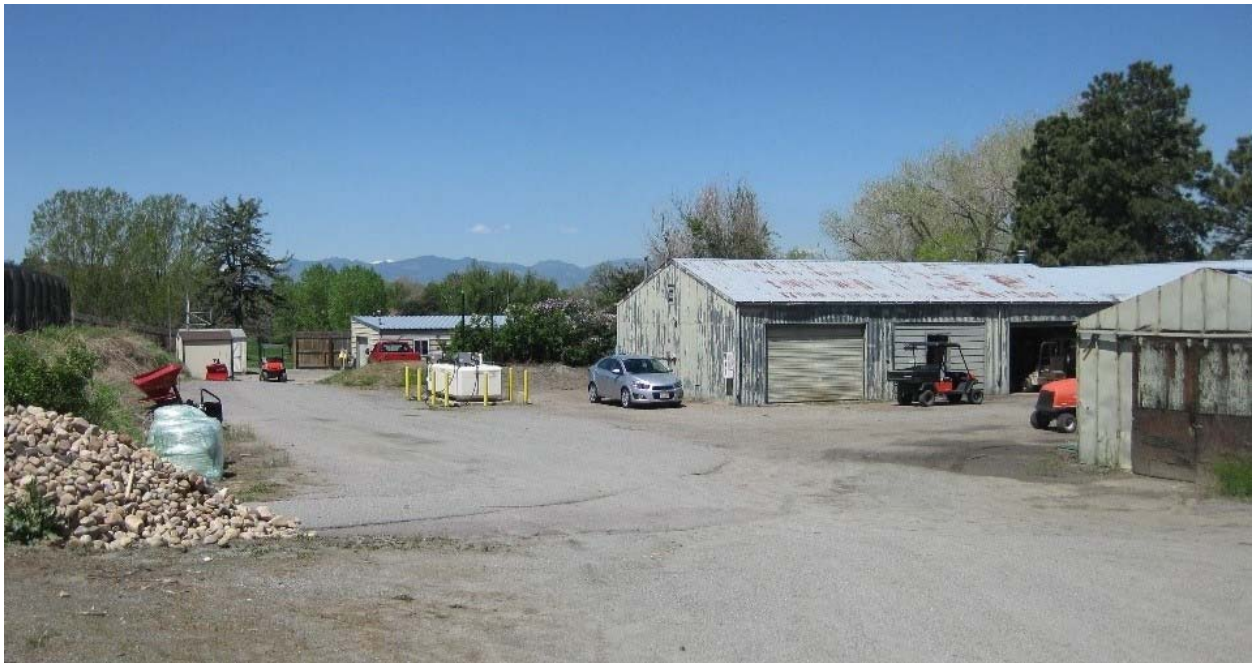
Figure 24. Maintenance and Storage Yard

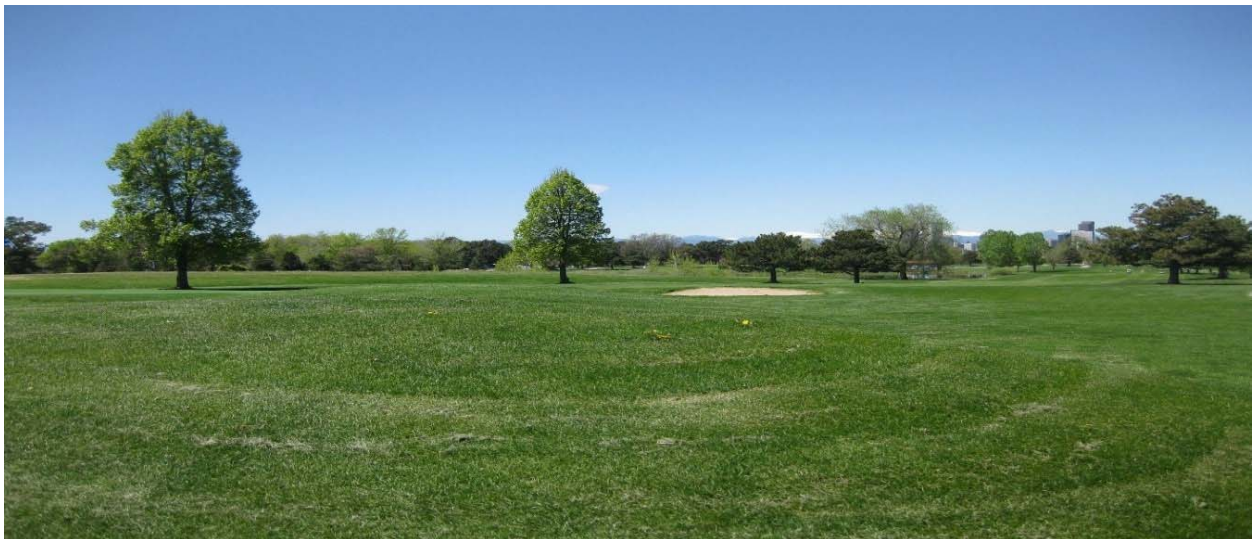
Figure 25. View of CPGC Looking Southwest Showing Topography Created by Fill from Pond Construction

The topography of CPGC has remained constant since the construction of the course. The course gradually slopes from its highest points on the east side of the site to its lowest points near the northwest corner of the parcel. The relatively flat, smooth area at the “top” of the course (the eastern third of the site) was given a more undulating feel in the early 2000s when dirt excavated for a new irrigation pond was used to create small hillocks and rises (see Figure 25).

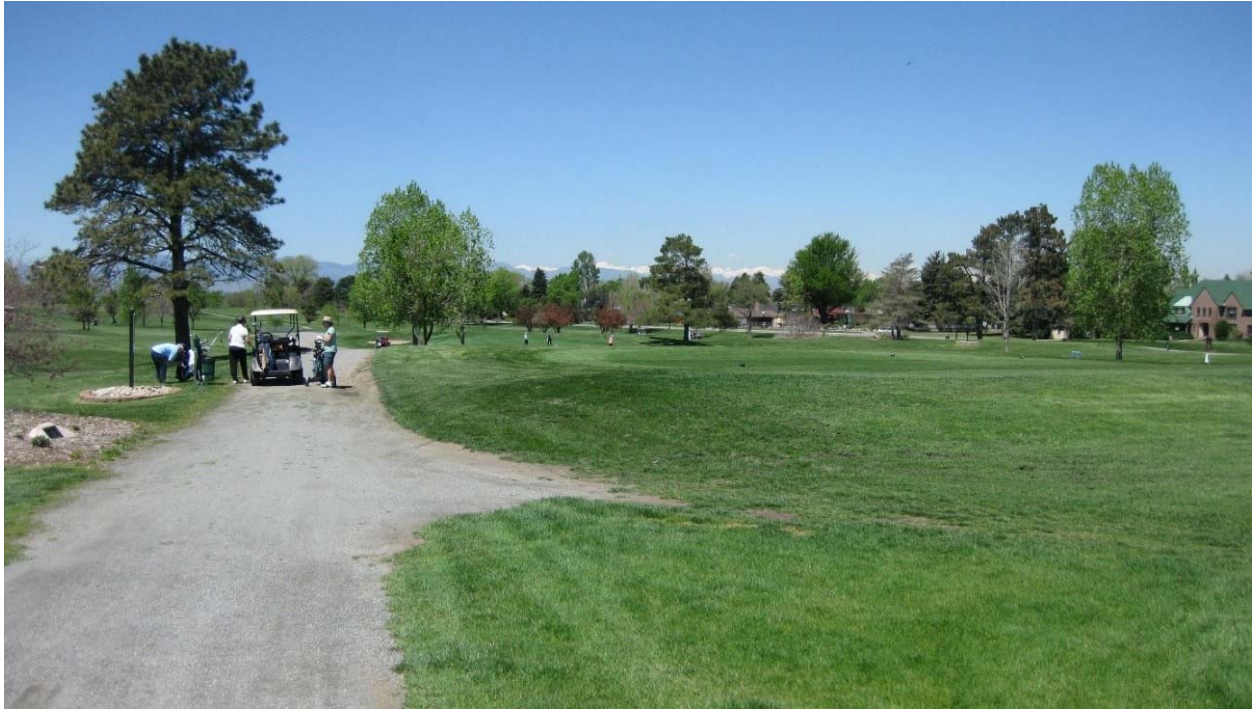
Figure 26. View of CPGC Looking Northwest Showing Extensive Grass and Vegetation

Today, CPGC consists of a lush, verdant space filled with trees, shrubs, grasses, and other vegetation, making it feel more like a park than a golf course. The installation of a complete irrigation system that waters every part of the course in the early 2000s has transformed the landscape, completing a process that began in the 1950s.

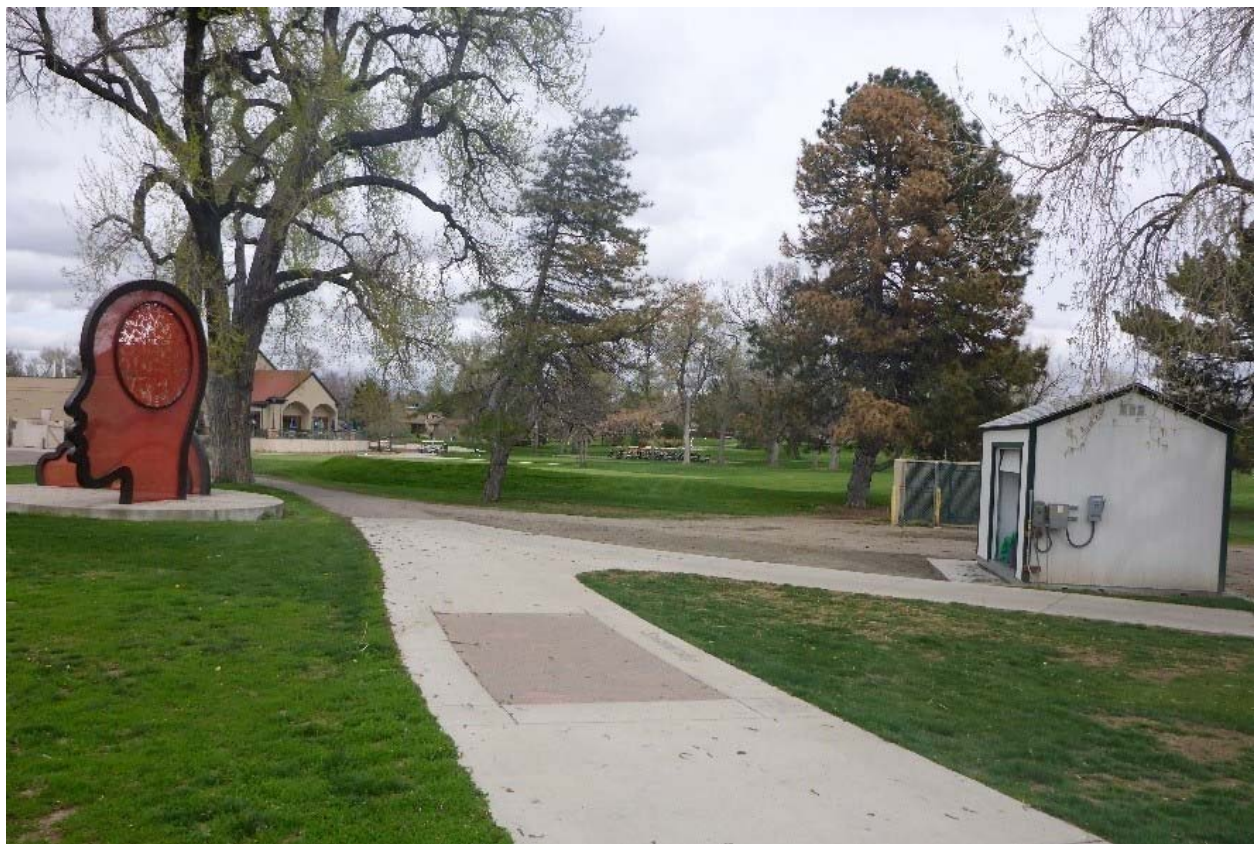
Note public art piece installed next to driving range.

The pedestrian experience is extremely limited or non-accommodating for non-golfers. The only formalized sidewalk is along York Street and it was constructed very recently (see Figure 27). Only social dirt paths exist around the perimeter of the north, east, and south sides. Paved sidewalks run along the west side of the course.

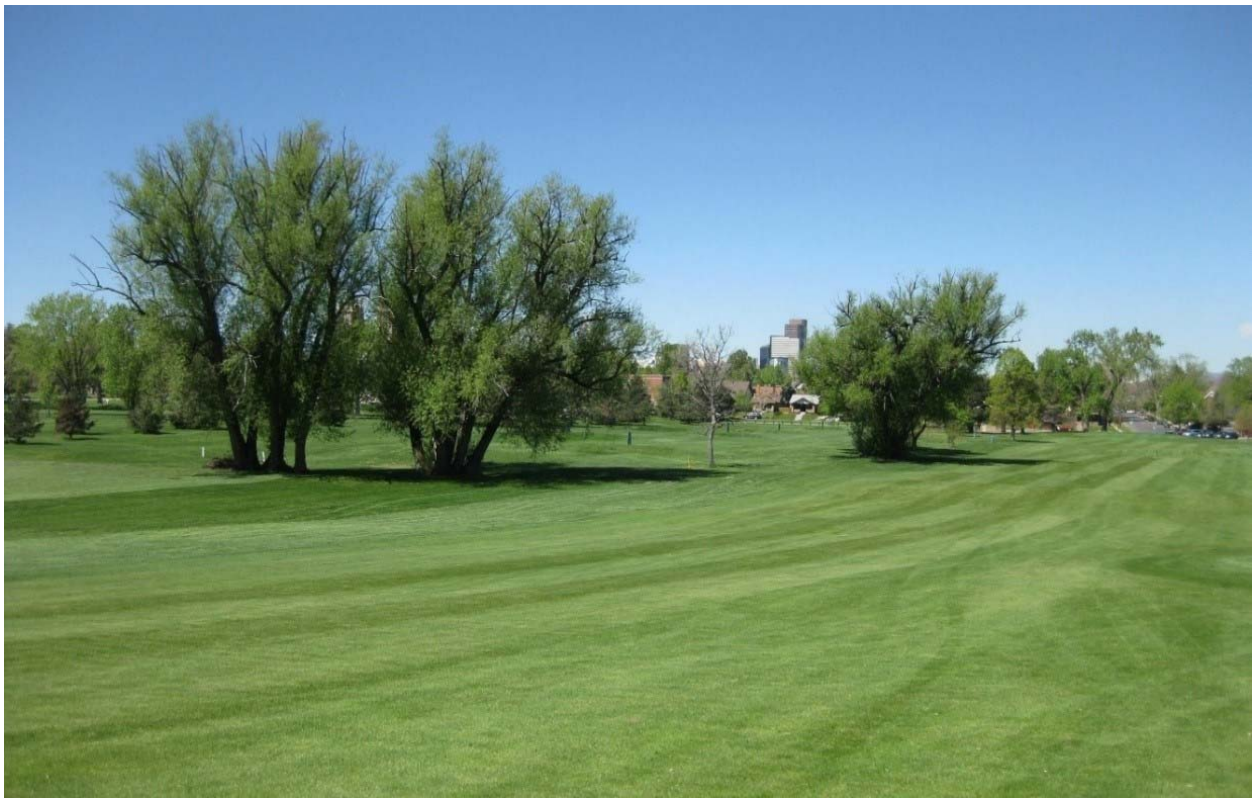
Figure 28. View of CPGC Looking West Showing Extensive Grass and Vegetation

Changes to the design of the course were even more evident by 1986. The design philosophy that Bendelow followed emphasized the Scottish link style, which used existing land forms and placed few, if any, trees on the landscape. He adhered to a look that used the natural features of a chosen site as much as possible. At the time Bendelow completed his design, the fairways and greens that he laid out consisted of sand and the open areas between these fairways contained natural grasses or were simply dirt.

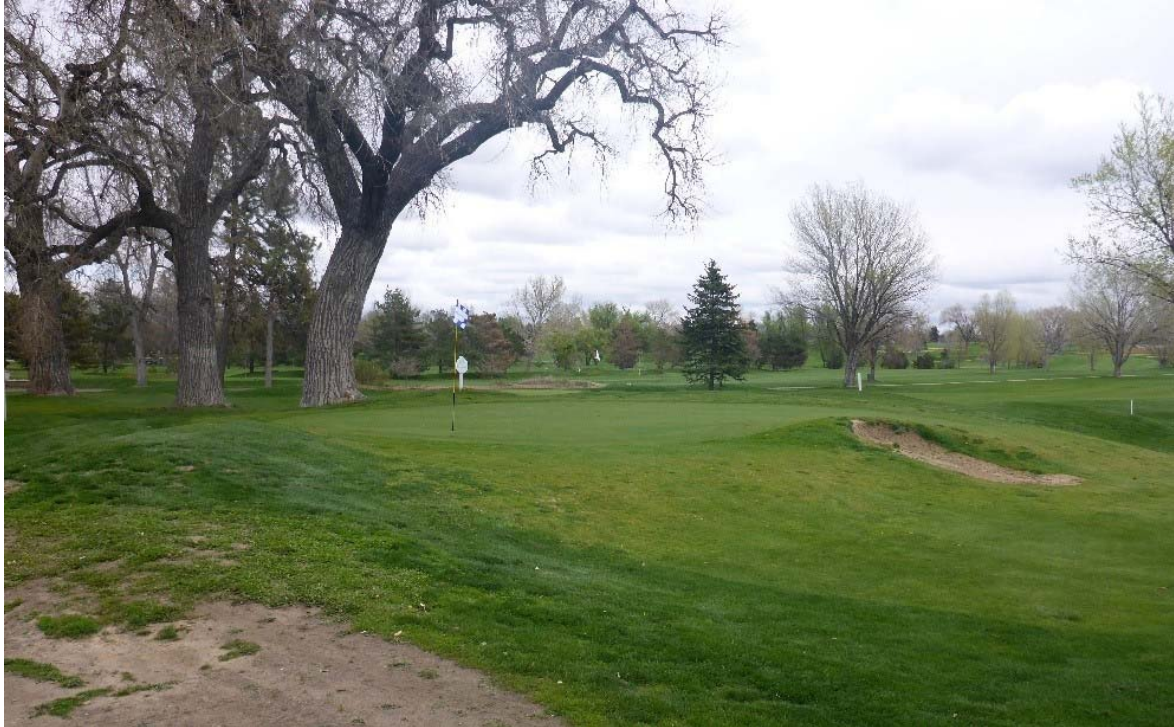
Figure 29. View of CPGC Looking East Showing undulating terrain on west side of course

occurred in 2001 also changed the western side of CPGC. (see Figure 29) and, later, by the installation of the First Tee youth golf program area (see Figure 30). This section of the course changed again in the early 2000s when dirt excavated from the irrigation pond on the southeast side of the course was placed next to the Number 10 fairway.

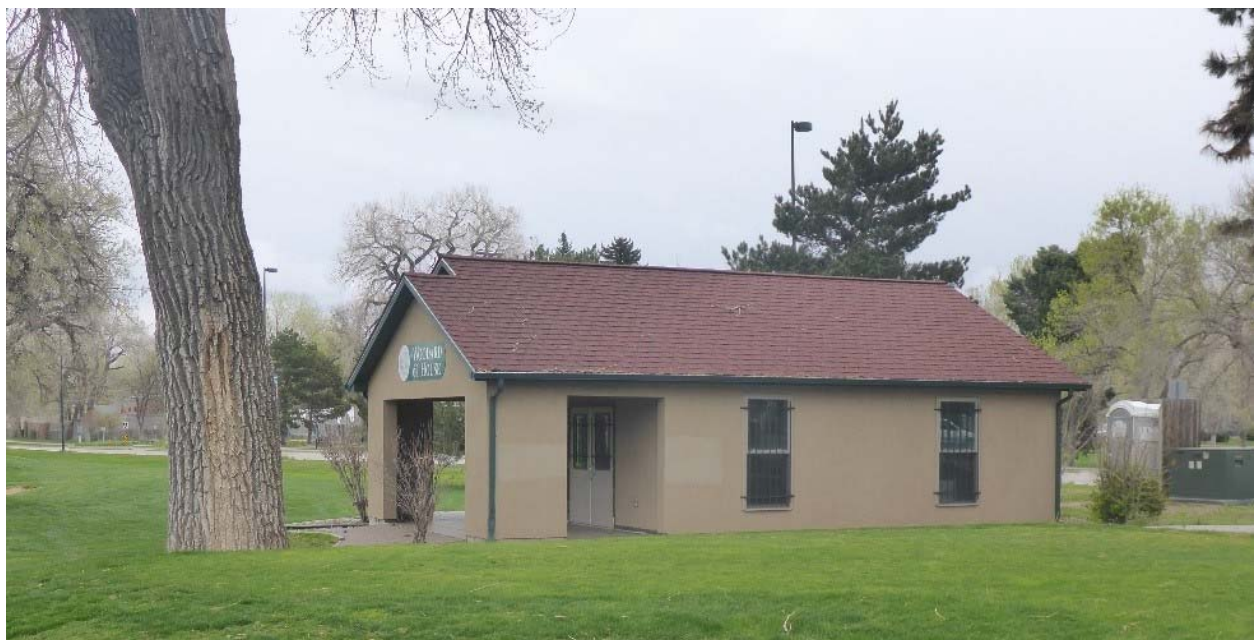
Figure 30. View of 2005 First Tee building
