City Park Golf Course Cultural Landscape Assessment

Denver, Colorado
August 2017

Prepared for:
City and County of Denver
Department of Public Works
201 West Colfax Avenue
Denver, CO 80202

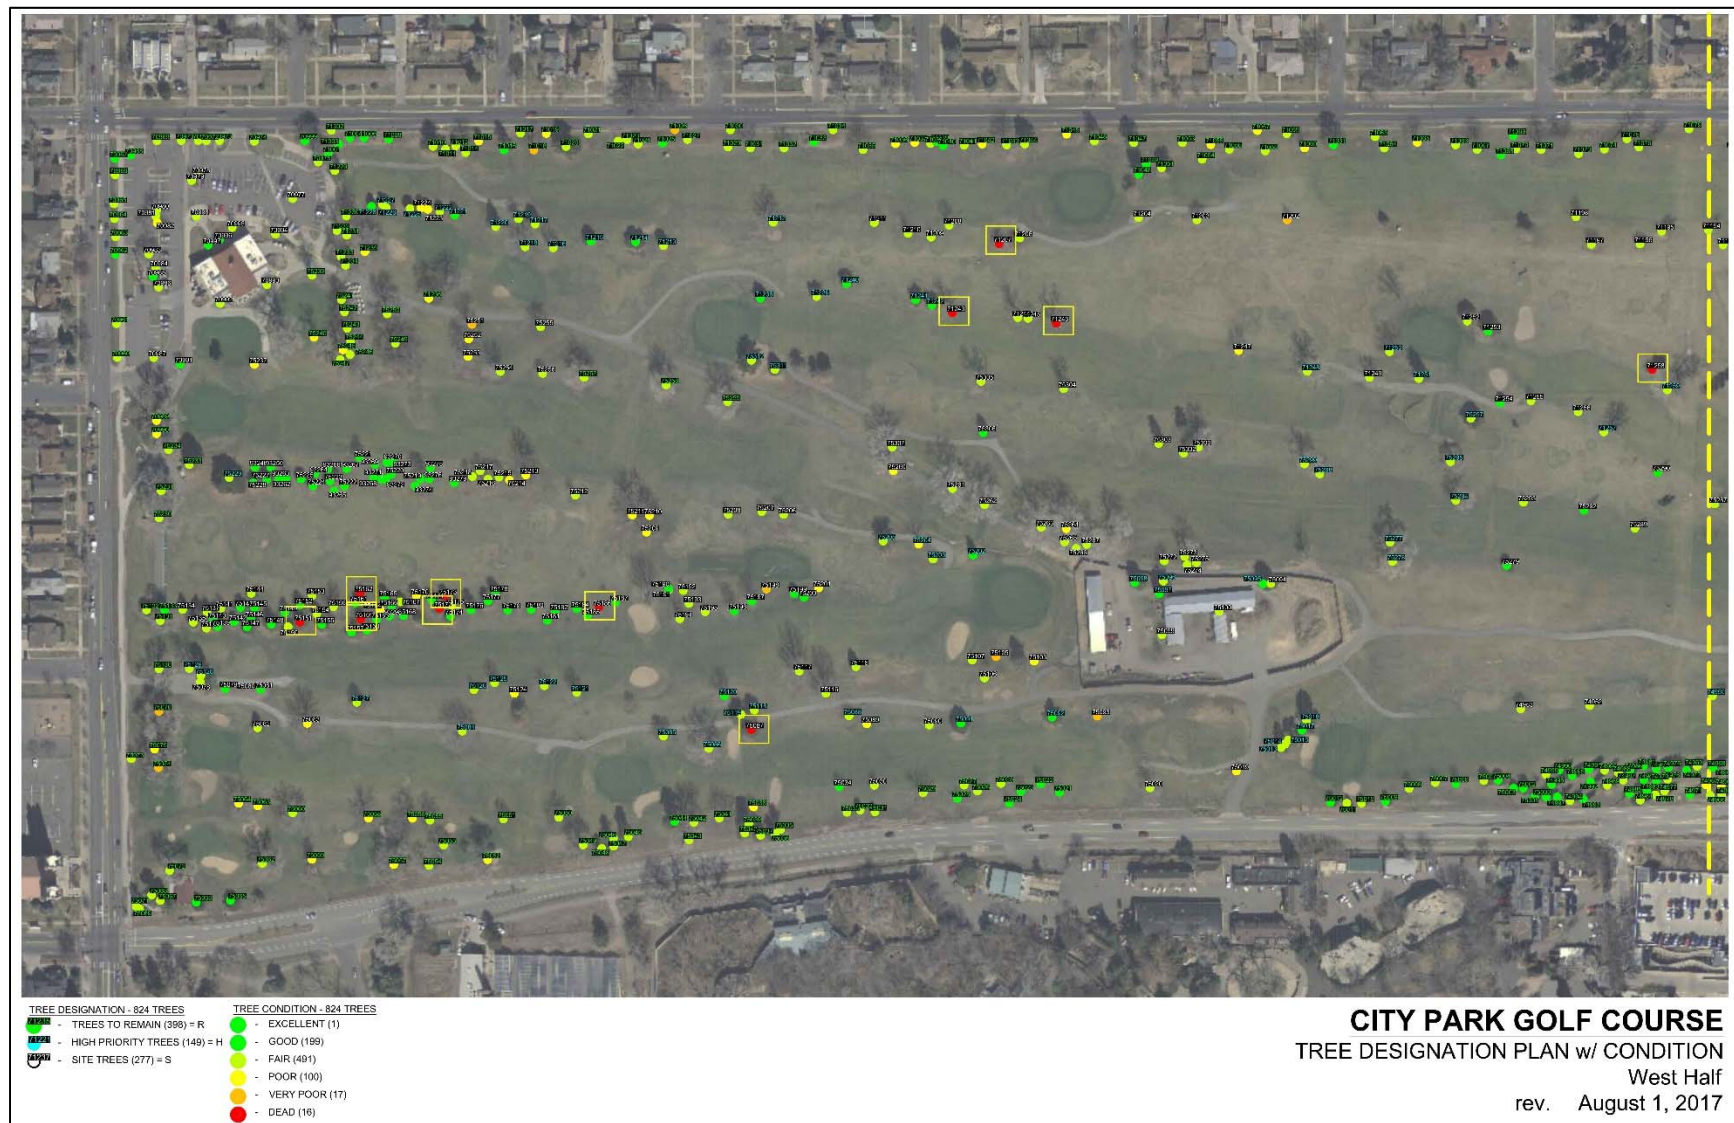
City Park Golf Course Tree Designation Plan with Condition, West Half.
Yellow boxes show trees that have died since the inventory.

In the 31 years that have passed since the NRHP nomination was completed, the City Forestry Department has carried out extensive inventories of the trees on the course and rated each based on their health and potential longevity. These surveys have found that many of the trees and plantings that were cited in the NRHP nomination have died or been replaced. A few of the oldest trees mentioned in the nomination (such as the cottonwoods along York Street and 23rd Avenue) are still standing, but they are now more than 100 years old and are reaching the end of their lifespan. Other species of trees on the site have been in place for 50 years or more. The results of the most recent tree inventory are included in Appendix A.

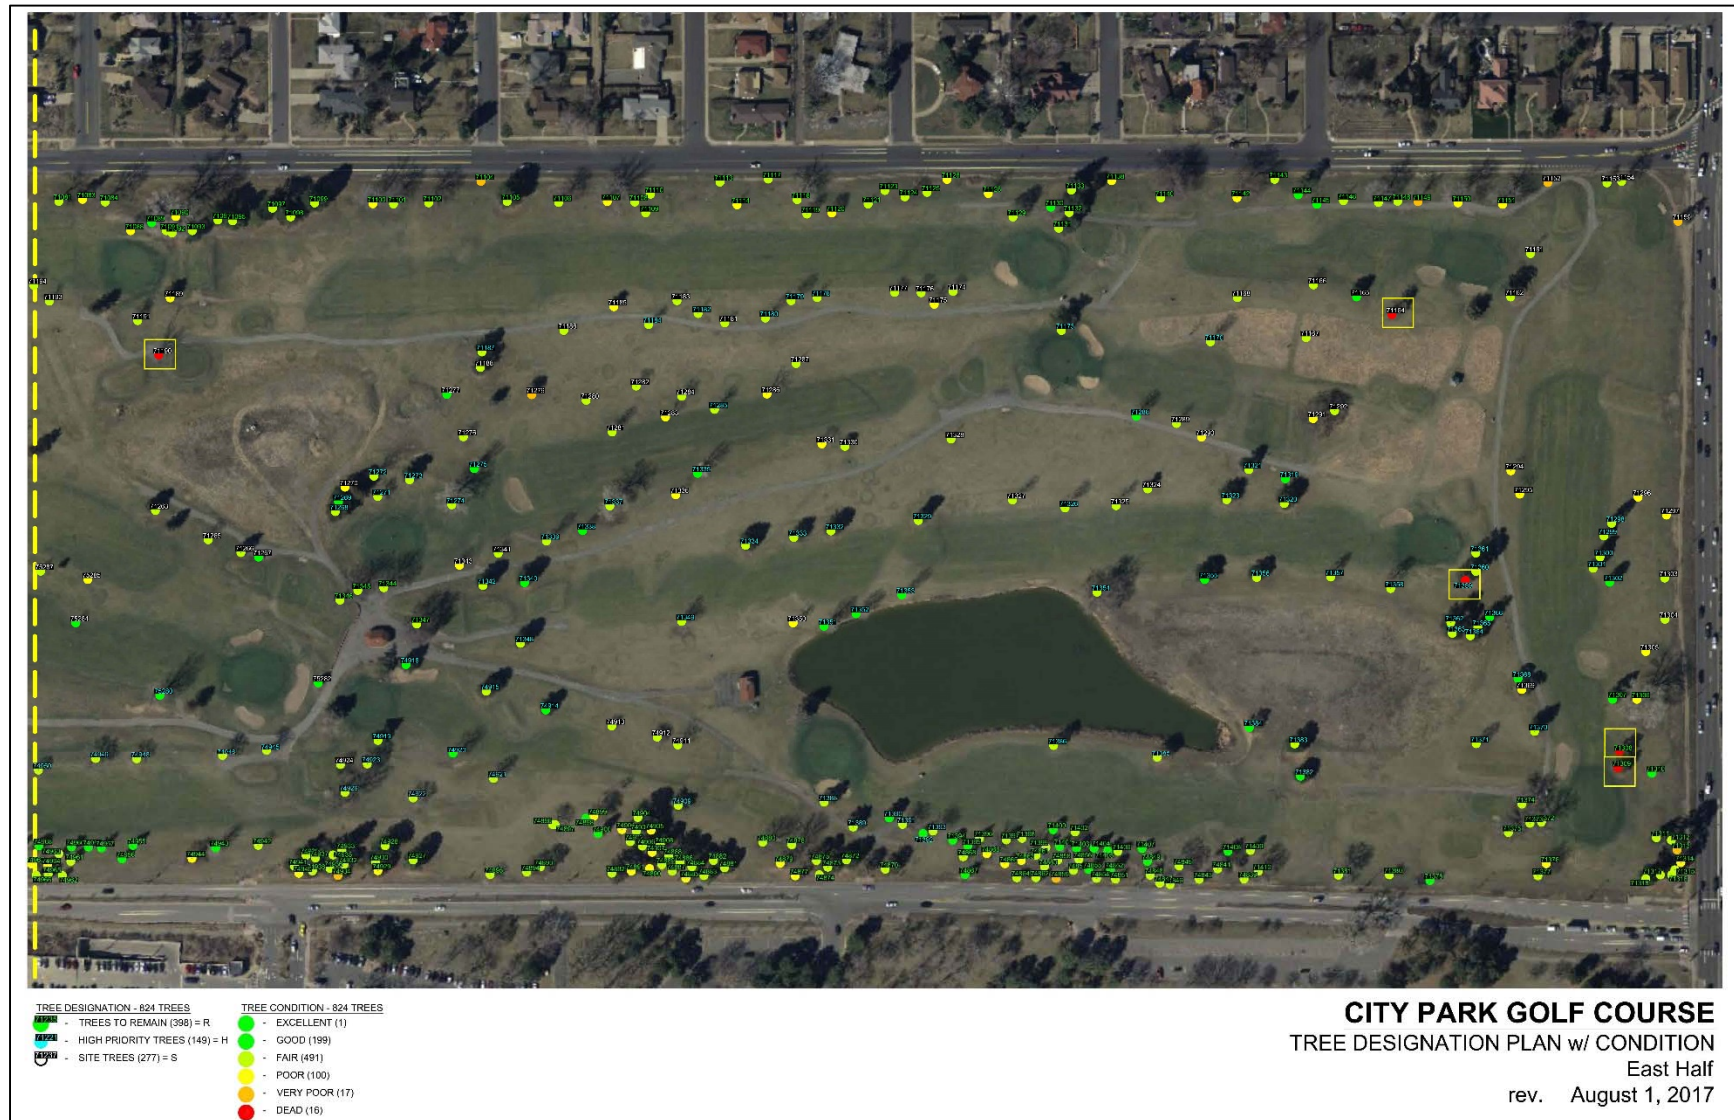
City Park Golf Course Tree Designation Plan with Condition, East Half
